2017 Annual Conference

COLLECTION REHAB
AND MAINTENANCE

COLLECTION REHAB AND MAINTENANCE

PART 1 - WASTEWATER COLLECTION SYSTEM OVERVIEW

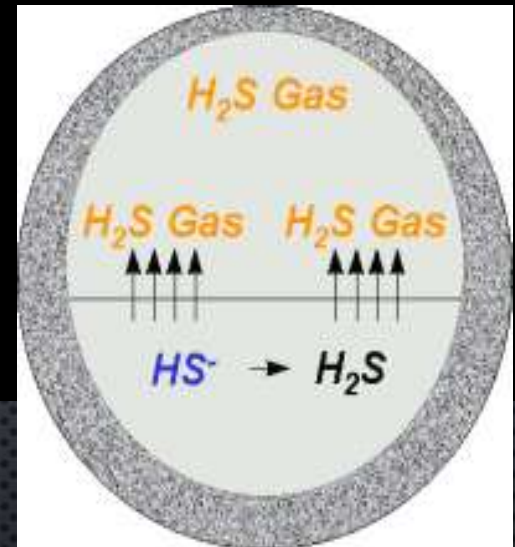
Chart from:
http://www.magnesiaspecialties.com/Thioguard/thio_direct.htm

HYDROGEN SULFIDE - ODOR

- HYDROGEN SULFIDE (H_2S) IS A PRODUCT OF STALE SEWAGE AND HAS A ROTTEN EGG SMELL.
- ODORS OCCUR WHEN WASTE WATER PH ALLOWS HYDROGEN SULFIDE TO EVOLVE FROM LIQUID PHASE HYDROSULFIDE (HS^-).
- STEAK, CHEESEBURGER, AND 3-DAY OLD NACHOS.
 - O_2
 - NO_x
 - SO_x

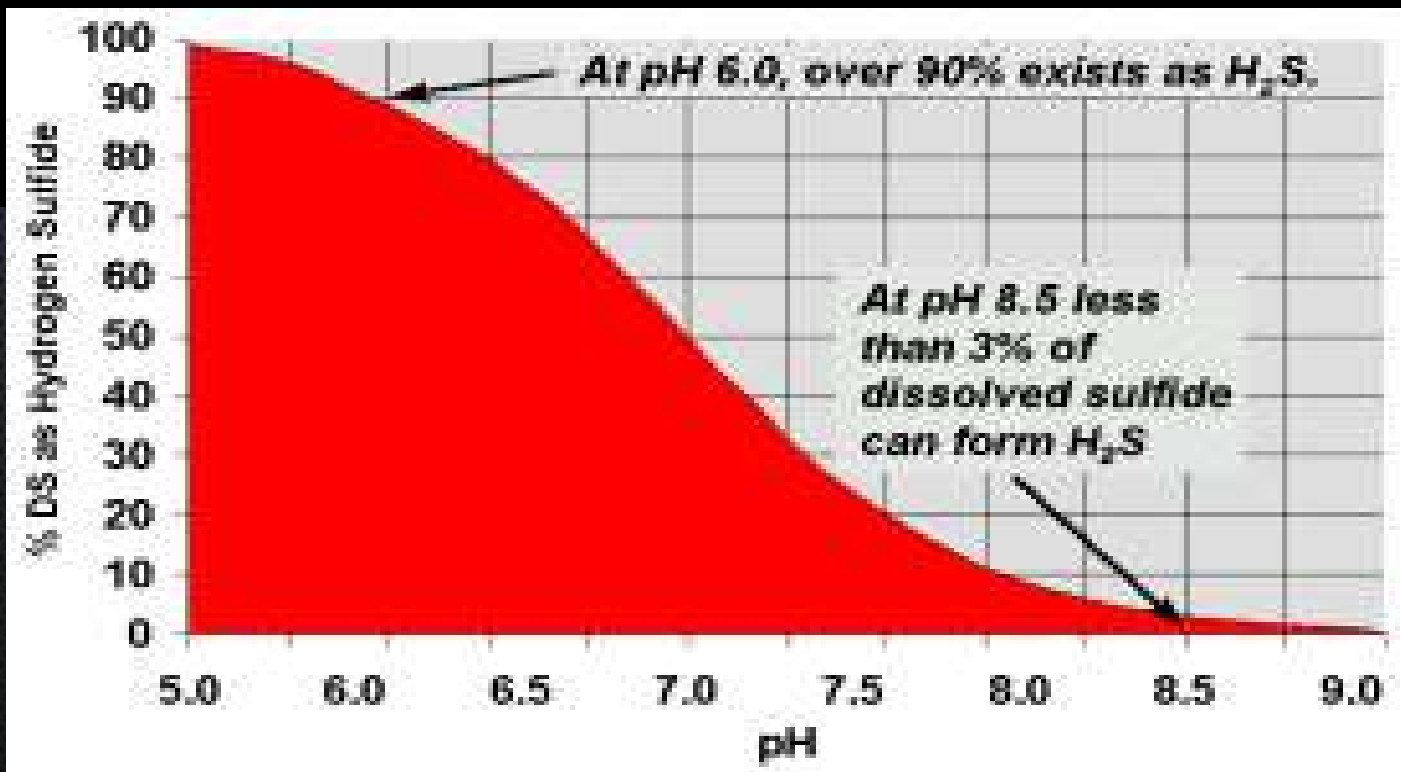
CHART FROM: [HTTP://WWW.MAGNESIASPECIALTIES.COM/THIOGUARD/THIO_DIRECT.HTM](http://www.magnesiaspecialties.com/thioguard/thio_direct.htm)

HYDROGEN SULFIDE - CORROSION

- CERTAIN BACTERIA CONVERT HYDROGEN SULFIDE (H_2S) TO SULFURIC ACID, WHICH IS VERY CORROSIVE TO ELECTRICAL EQUIPMENT AND TO CONCRETE, IRON, AND STEEL.

HYDROGEN SULFIDE - CORROSION

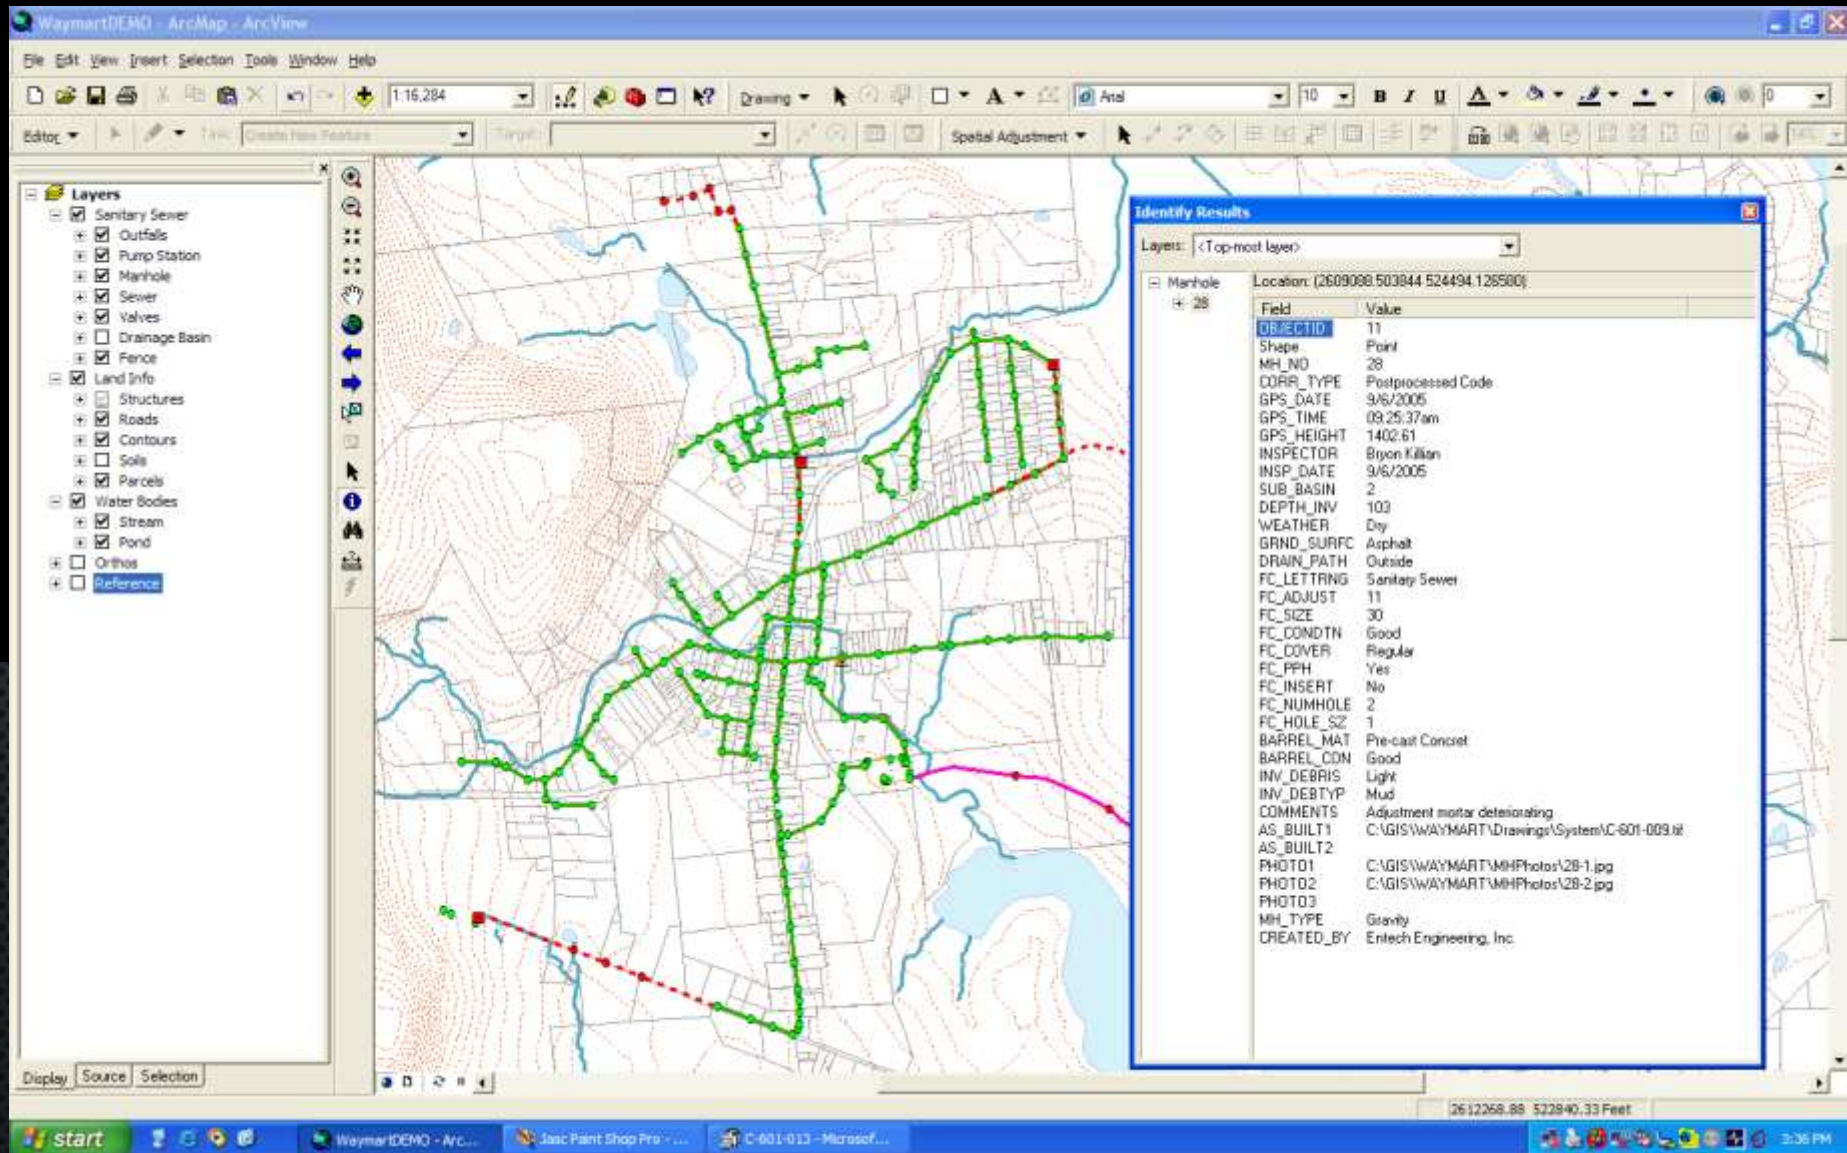
GIS DATABASE DEVELOPMENT

- Sanitary Sewer
- Outfalls
- Pump Station
- Manhole
- Sewer
- Valves
- Drainage Basin
- Fence
- Land Info
- Structures
- Roads
- Contours
- Soils
- Parcels
- Water Bodies
- Stream
- Pond
- Orthos
- Reference

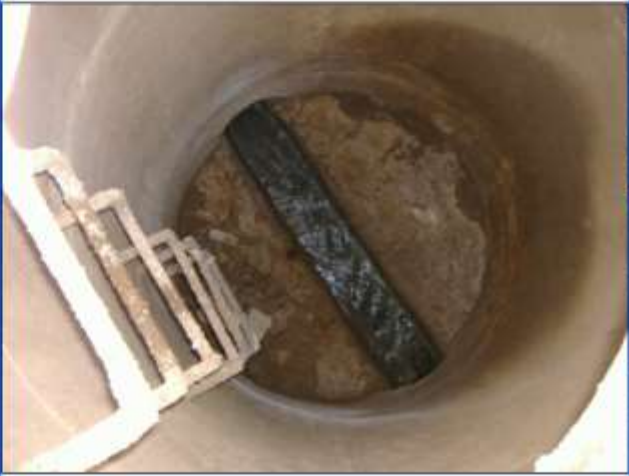
Identify Results

Field	Value
OBJECTID	11
Shape	Point
MH_NO	28
CORR_TYPE	Postprocessed Code
GPS_DATE	9/6/2005
GPS_TIME	09:29:37am
GPS_HEIGHT	1402.61
INSPECTOR	Bryan Kilian
INSP_DATE	9/6/2005
SUB_BASIN	2
DEPTH_INV	103
WEATHER	Dry
GRND_SURFC	Asphalt
DRAIN_PATH	Outside
FC_LETTRNG	Sanitary Sewer
FC_ADJUST	11
FC_SIZE	30
FC_CONDITN	Good
FC_COVER	Regular
FC_PPH	Yes
FC_INSERT	No
FC_NUMHOLE	2
FC_HOLE_S2	1
BARREL_MAT	Pre-cast Concret
BARREL_CON	Good
INV_DEBRIS	Light
INV_DEBTYP	Mud
COMMENTS	Adjustment motor deteriorating
AS_BUILT1	C:\GIS\WAYMART\Drawings\System\C-601-003.kit
AS_BUILT2	
PHOTO1	C:\GIS\WAYMART\MHPhotos\28-1.jpg
PHOTO2	C:\GIS\WAYMART\MHPhotos\28-2.jpg
PHOTO3	
MH_TYPE	Gravity
CREATED_BY	Entech Engineering, Inc.

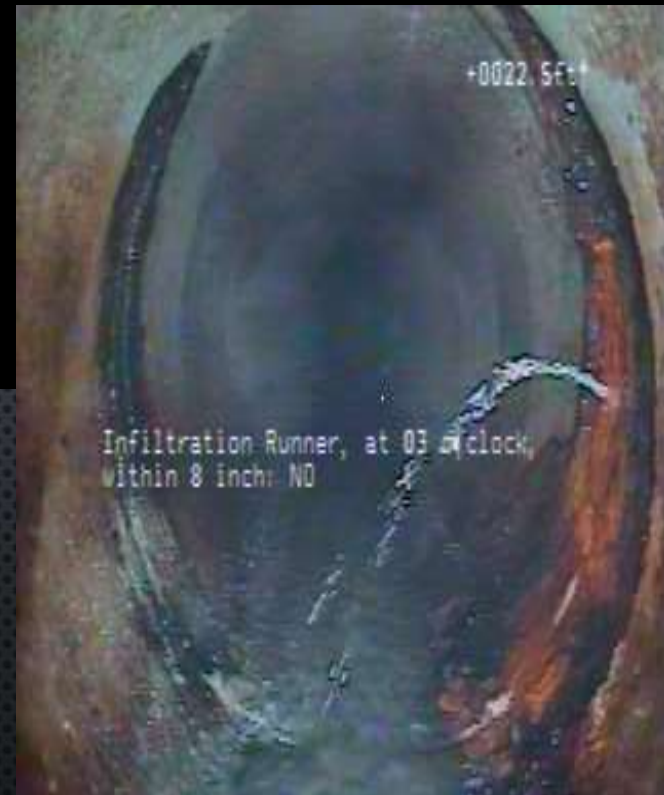
QUICK REVIEW: INFILTRATION (GROUND WATER)

- INFILTRATION – “THE TOTAL EXTRANEEOUS FLOW ENTERING A SEWER SYSTEM OR PORTIONS THEREOF, EXCLUDING SANITARY SEWAGE, BECAUSE OF POOR CONSTRUCTION, CORROSION OF THE PIPE FROM THE INSIDE OR OUTSIDE, GROUND MOVEMENT OR STRUCTURAL FAILURE THROUGH JOINTS, POROUS WALLS OR BREAKS.”
- WPCF MOP No. FD-5

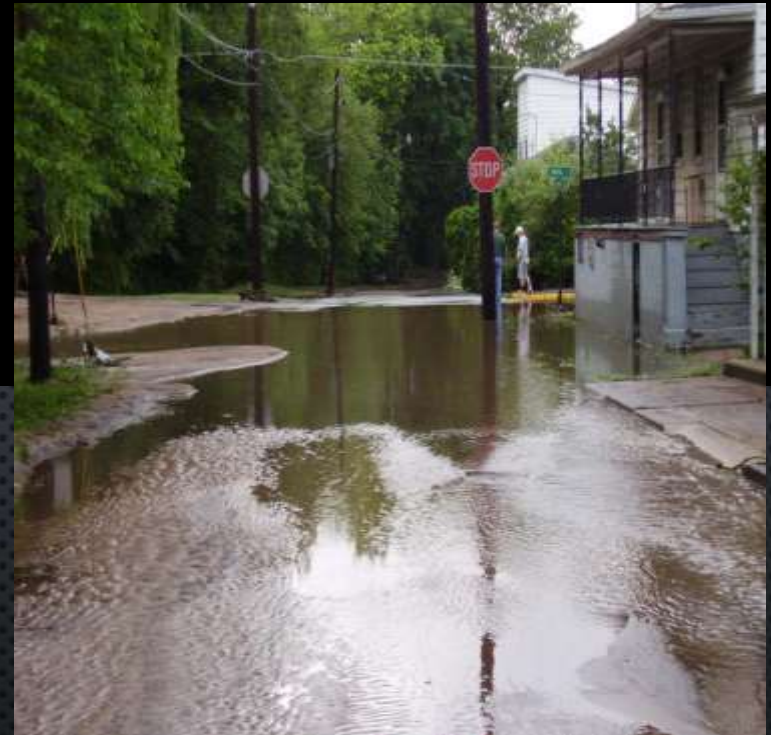
QUICK REVIEW: INFLOW (SURFACE WATER)

- INFLOW – “THE EXTRANEEOUS FLOW WHICH ENTERS A SANITARY SEWER FROM SOURCES OTHER THAN INFILTRATION, SUCH AS ROOF LEADERS, BASEMENT DRAINS, LAND DRAINS, AND MANHOLE COVERS. INFLOW, IN SHORT, IS USUALLY MAN MADE AND INTENTIONAL.”
- WPCF MOP No. FD-5

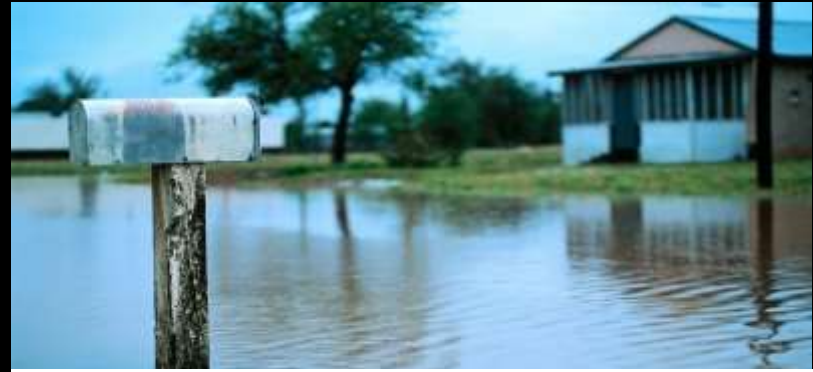
INFLOW & MH COVERS

- TESTS MADE ON MANHOLE COVERS SUBMERGED IN ONLY 1-INCH OF WATER INDICATE THAT THE LEAKAGE RATE PER MANHOLE MAY BE FROM 20 TO 75 GPM DEPENDING ON THE NUMBER AND SIZE OF HOLES IN THE COVER.
 - RAWN, A.M., "WHAT COST LEAKING MANHOLE?" WATERWORKS AND SEWAGE, VOL, 84, 12, PG. 45, 1937.
- MH PENETRATING PICK HOLES ARE COMMON HOLES IN COVERS.
- SOLID WATERTIGHT COVERS ARE TO BE USED WHENEVER THE MANHOLE TOPS MAY BE FLOODED BY STREET RUNOFF OR HIGH WATER.
 - PADEP DOMESTIC WASTEWATER FACILITIES MANUAL (10/97), PAGE 20
- MH DISHES

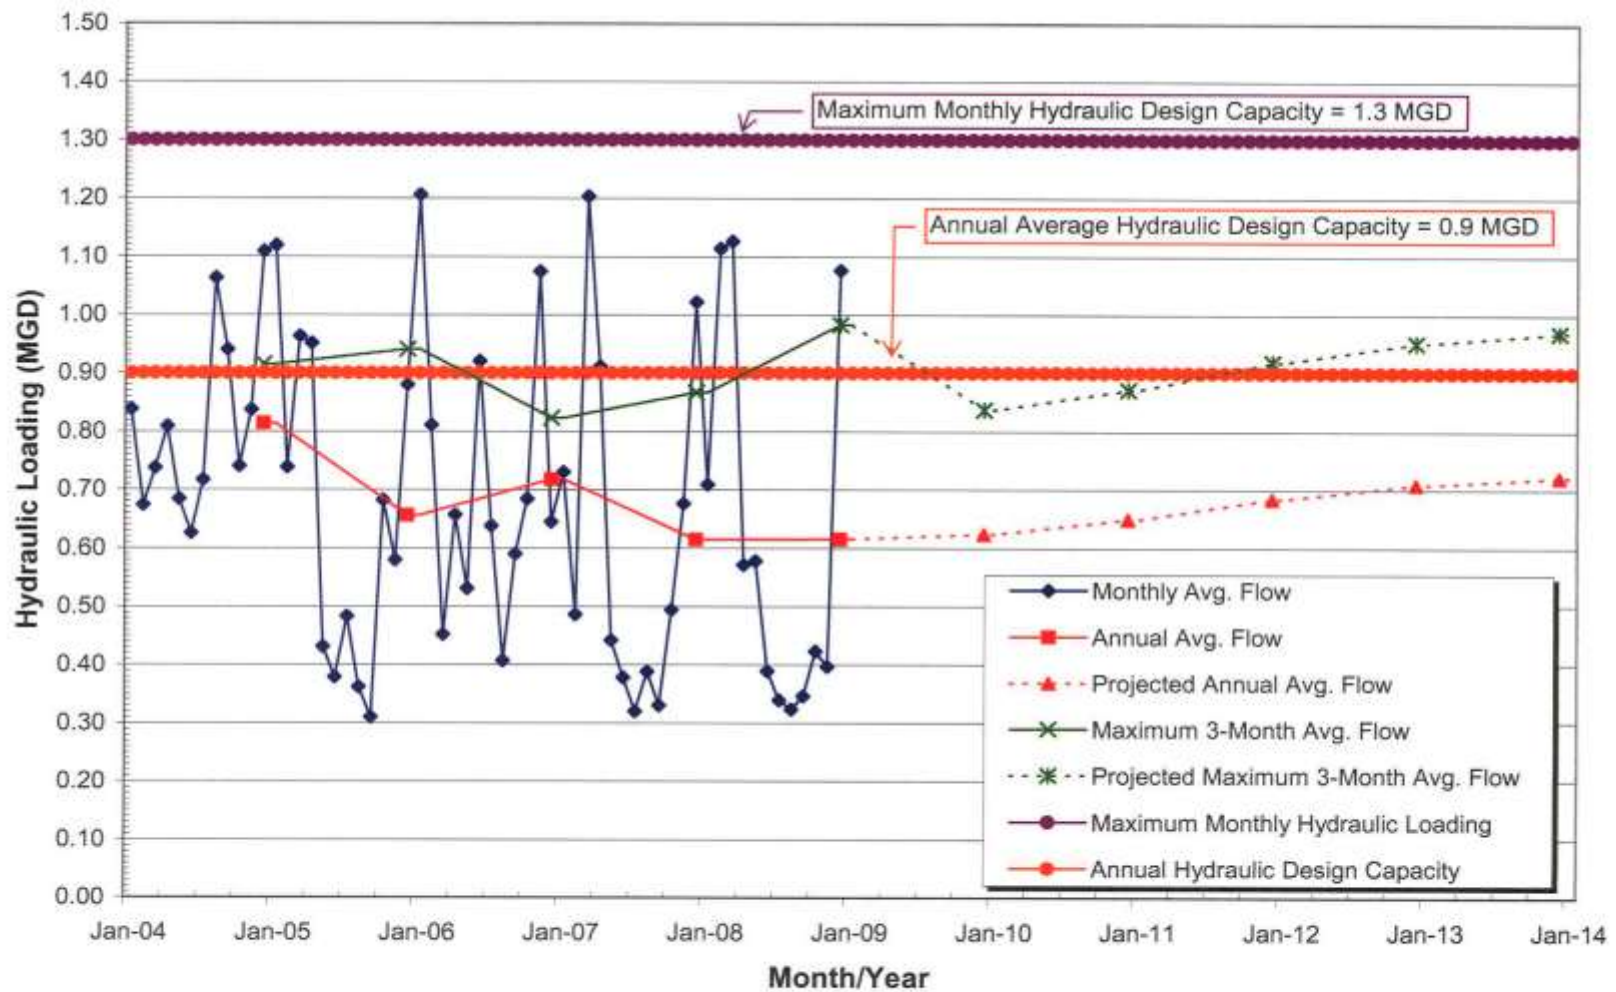
FIGURE 2A
Hydraulic Loading

TABLE 2-1
Hydraulic Loading Data

RATIO (MAX 3-MONTH TO ANNUAL AVERAGE)	1.123	1.432	1.146	1.409	1.596					
AVERAGE OF 5-YEAR RATIOS	1.34

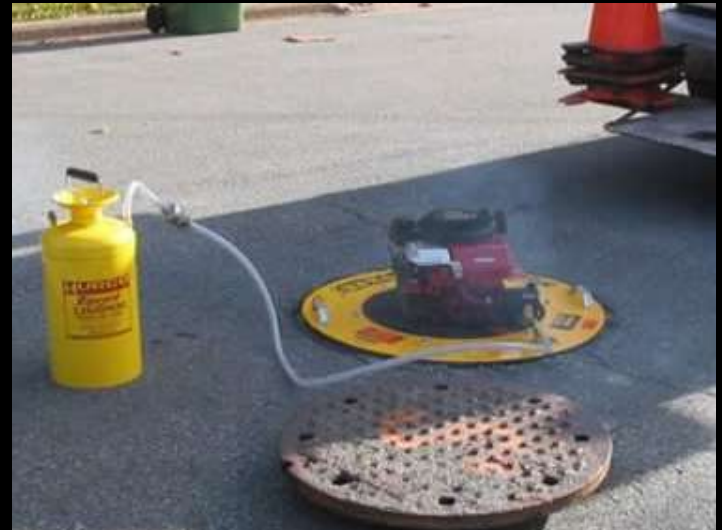
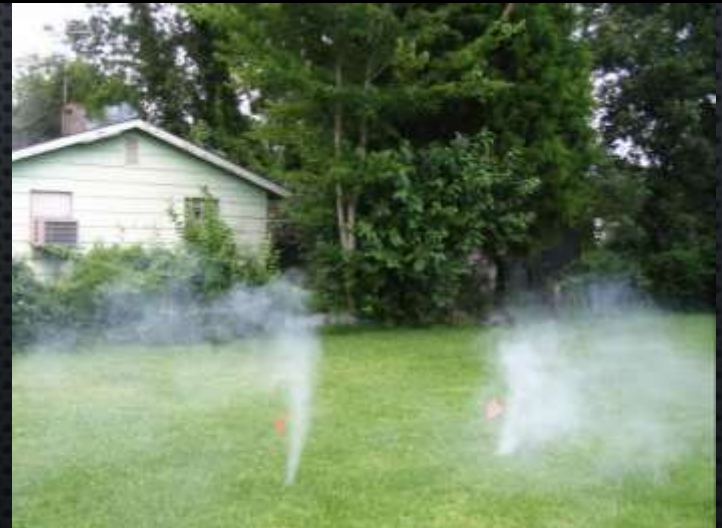
- AN EASY AND COST EFFECTIVE METHOD TO IDENTIFY I&I.
- SMOKE TESTING CAN IDENTIFY ILLEGAL CONNECTIONS, STORM WATER CROSS CONNECTIONS, ABANDONED LINES NOT PROPERLY PLUGGED, CRACKED PIPES, AND BAD SERVICE CONNECTIONS.
- PROPER TRAP DOES NOT ALLOW SMOKE TO ENTER.

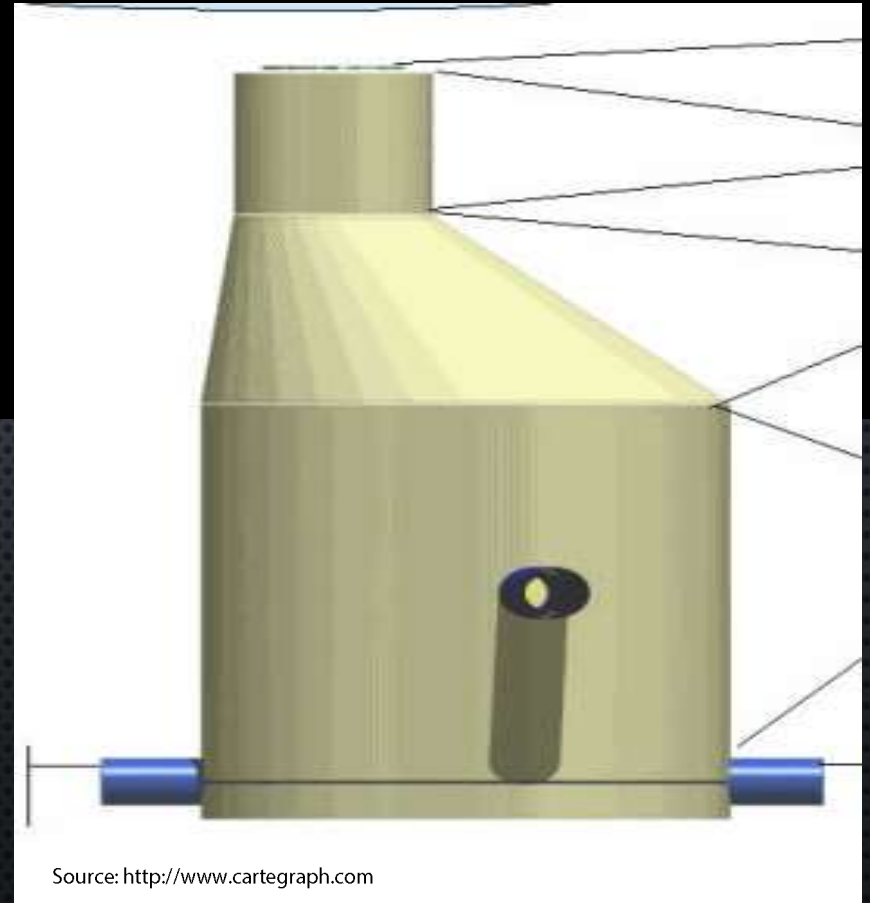
MANHOLE COMPONENTS

- FRAME / COVER
- CHIMNEY
- CONE / CORBEL
- BARREL SECTION
- BENCH
- CHANNEL / INVERT
- INLET / OUTLET PIPE

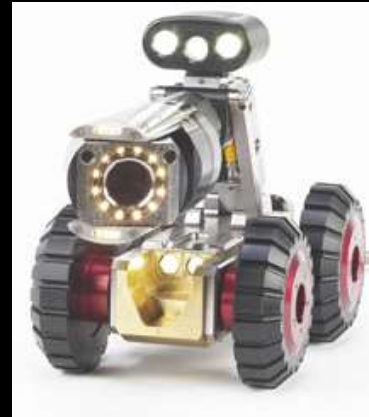
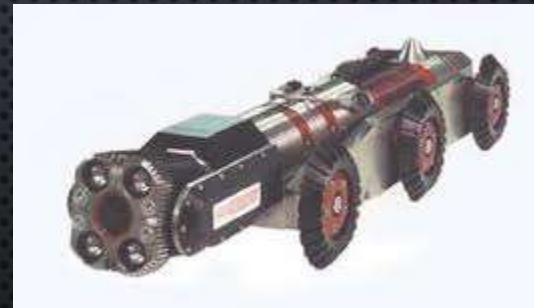
CCTV INSPECTION

- CERTIFIED OPERATOR - PACP
- MAX SPEED = 30 FT / MIN
- TRACKED, WHEELED, BOAT AND LATERAL LAUNCHING SYSTEMS
- PAN, TILT & ZOOM CAMERA
- DVD, VIEWING SOFTWARE, REPORT & INDEX

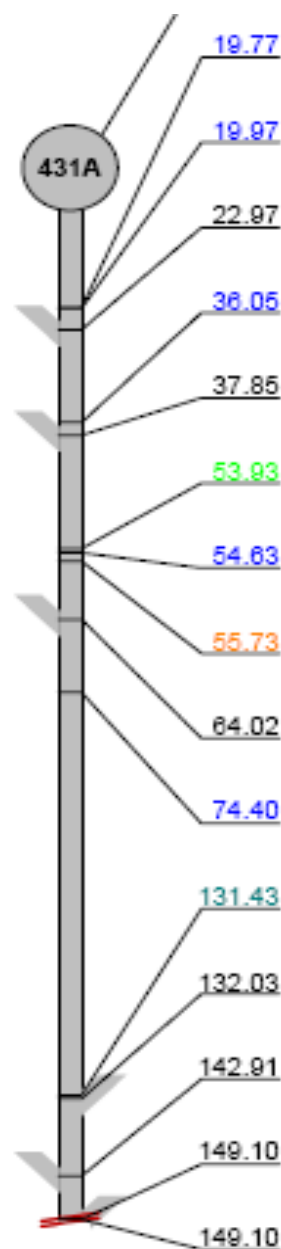
Roots Fine Joint, from 06 to 09 o'clock, within 8 inches of joint: YES	00:02:01	
Crack Longitudinal, at 12 o'clock, within 8 inches of joint: YES	00:02:36	2_3A
Tap Factory Made Capped, at 03 o'clock, 6", within 8 inches of joint: YES	00:03:23	
Fracture Circumferential, from 12 to 12 o'clock, within 8 inches of joint: NO	00:04:31	2_5A
Tap Factory Made, at 03 o'clock, 6", within 8 inches of joint: YES	00:05:10	
Joint Offset Medium	00:05:58	2_7A
Fracture Circumferential, from 12 to 12 o'clock, within 8 inches of joint: YES	00:06:24	2_8A
Infiltration Dripper, at 03 o'clock, within 8 inches of joint: YES, REMARK: Evidence of infiltration	00:06:48	2_9A
Tap Factory Made Capped, at 03 o'clock, 6", within 8 inches of joint: YES	00:07:31	
Crack Longitudinal, at 12 o'clock, within 8 inches of joint: YES	00:08:26	2_11A
Hole, from 12 to 06 o'clock, within 8 inches of joint: YES	00:13:33	2_12A
Tap Factory Made Capped, at 09 o'clock, 6", within 8 inches of joint: YES	00:13:56

Tap Factory Made Capped, at 03 o'clock, 6", within 8 inches of joint: YES	00:14:39	
Tap Break-In Active, at 11 o'clock, 6", within 8 inches of joint: YES	00:15:20	
Survey Abandoned, REMARK:	00:15:20	2_16A

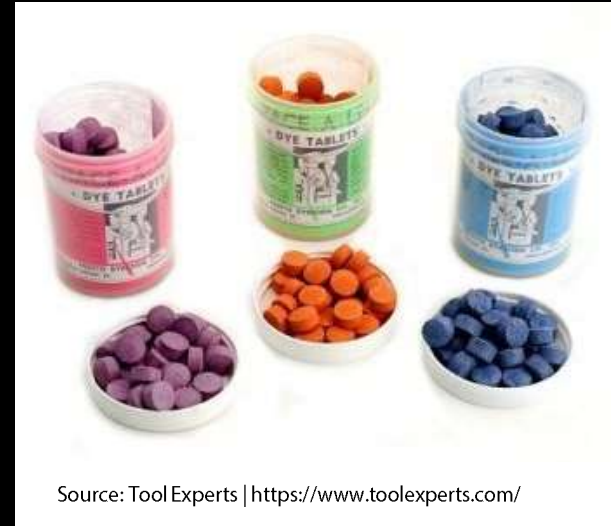
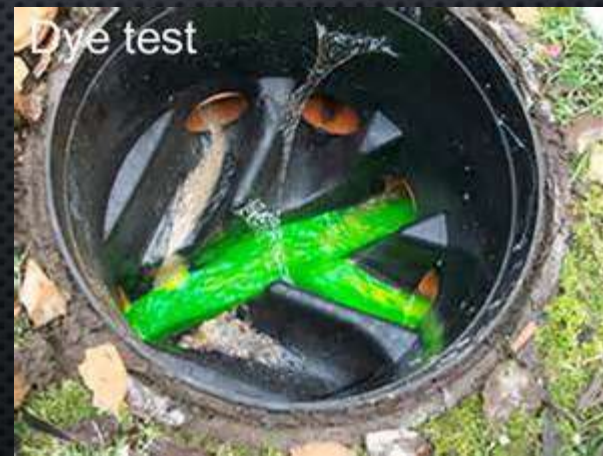
DYE TESTING

- VERIFICATION OF SUSPECT SOURCES
 - ROOF LEADERS
 - STORM INLETS
 - UNKNOWN PIPES

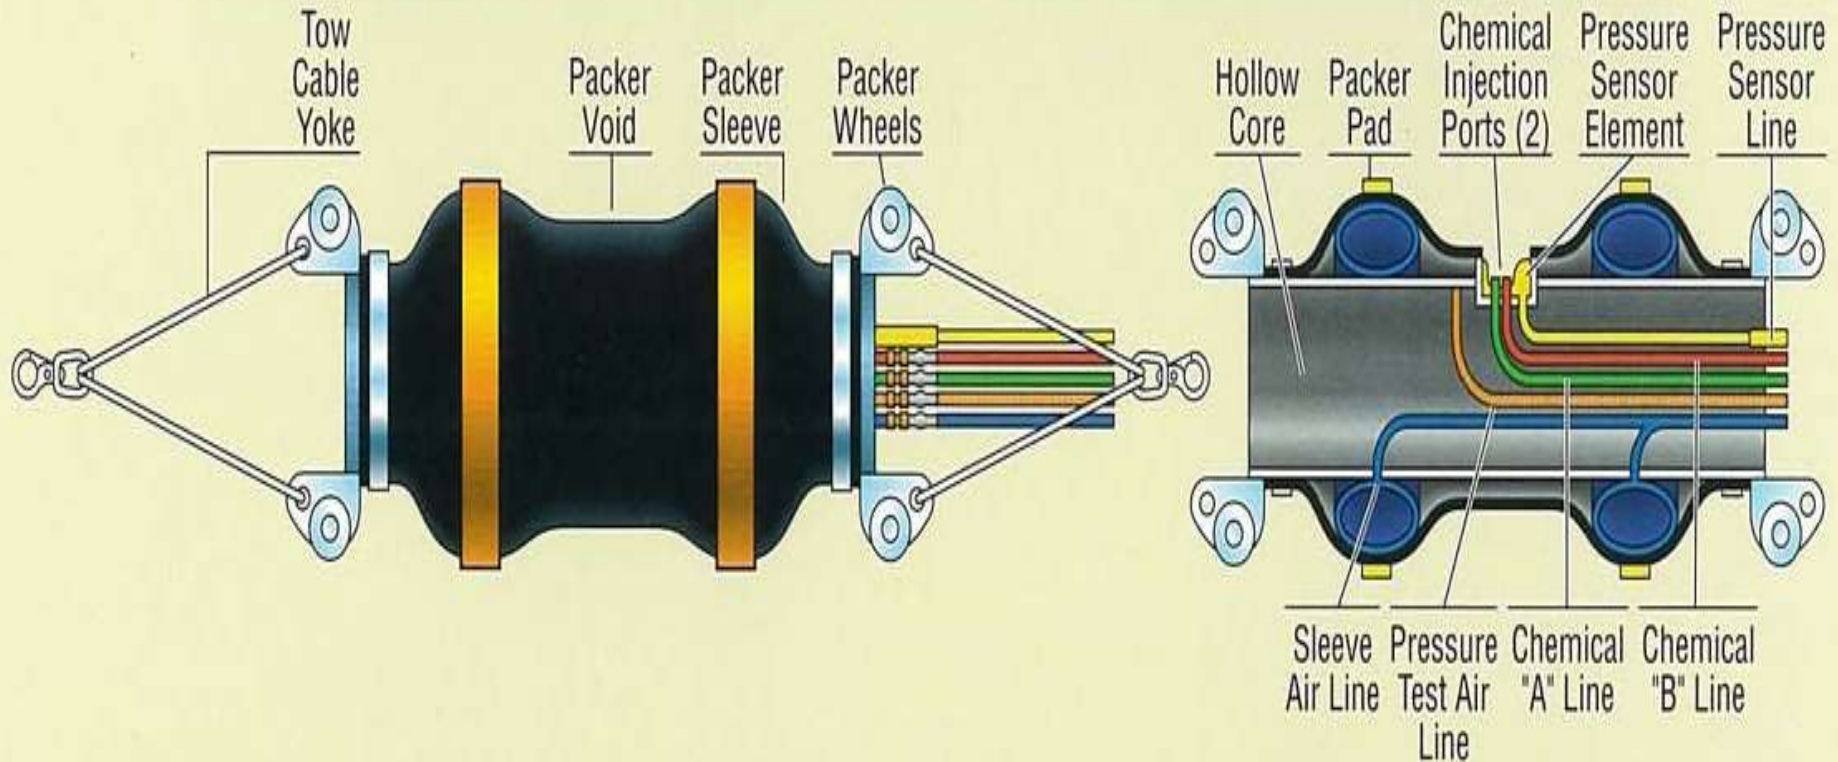
ANATOMY OF A MAINLINE TEST/SEAL PACKER

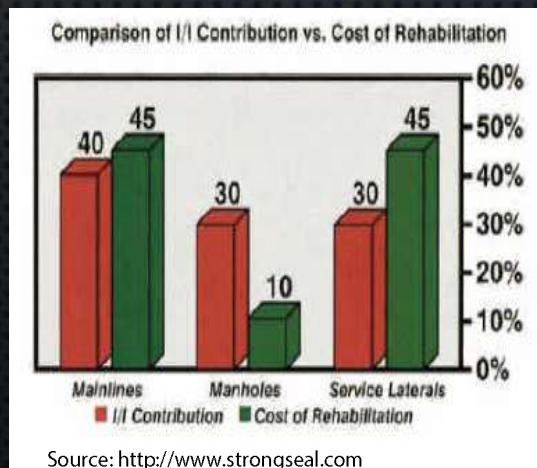
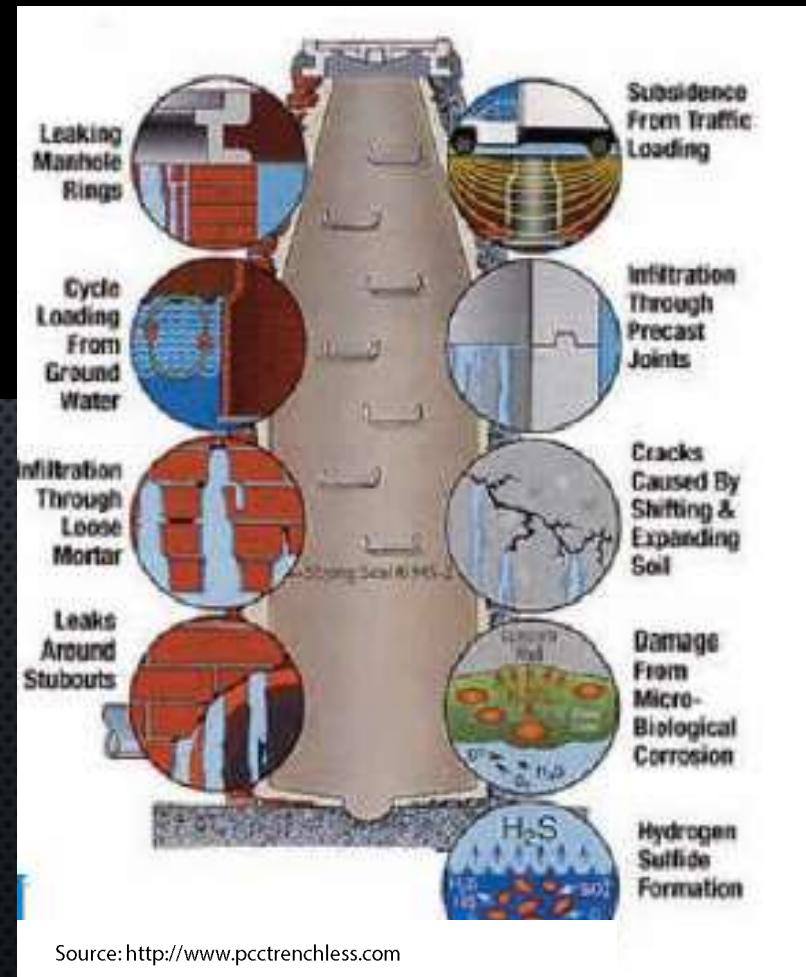
MANHOLE REHABILITATION

- “LOW-LYING FRUIT”
- COST-EFFECTIVE
- GROUTING
- CEMENTITIOUS VS EPOXY SPRAYS
 - SELECTION CRITERIA
- CHIMNEY SEAL

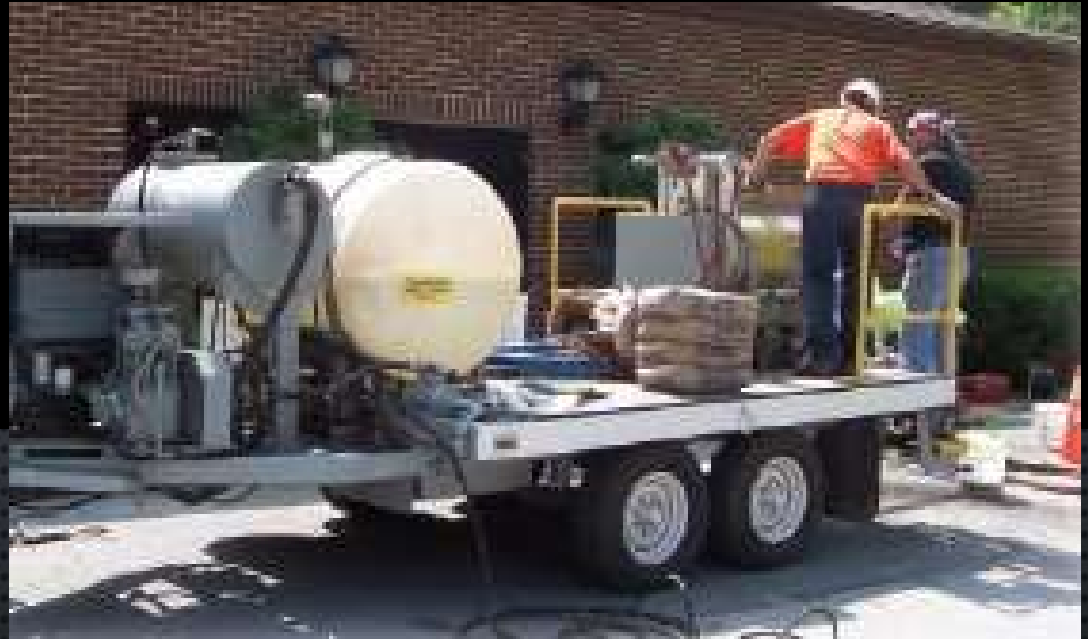
MONOLITHIC CEMENTITIOUS COATING

- PRESSURE WASH
- STOP LEAKS
- PROFILE HOLES
- SPIN-CAST
- BENCH / CHANNEL
- HARD WITHIN HOURS

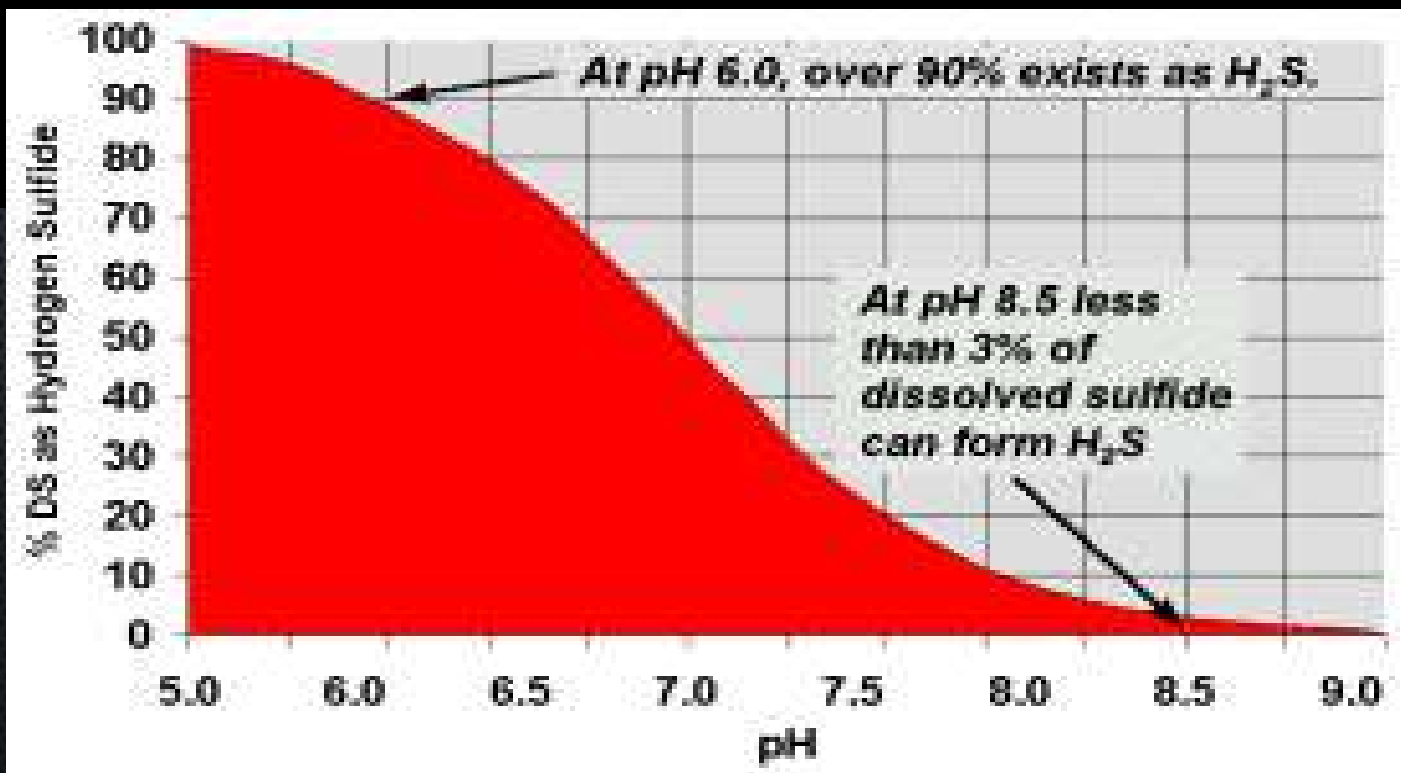
- CERTAIN BACTERIA CONVERT HYDROGEN SULFIDE (H_2S) TO SULFURIC ACID, WHICH IS VERY CORROSIVE TO ELECTRICAL EQUIPMENT AND TO CONCRETE, IRON, AND STEEL.

CHART FROM: [HTTP://WWW.MAGNESIASPECIALTIES.COM/THIOGUARD/THIO_DIRECT.HTM](http://www.magnesiaspecialties.com/thioguard/thio_direct.htm)

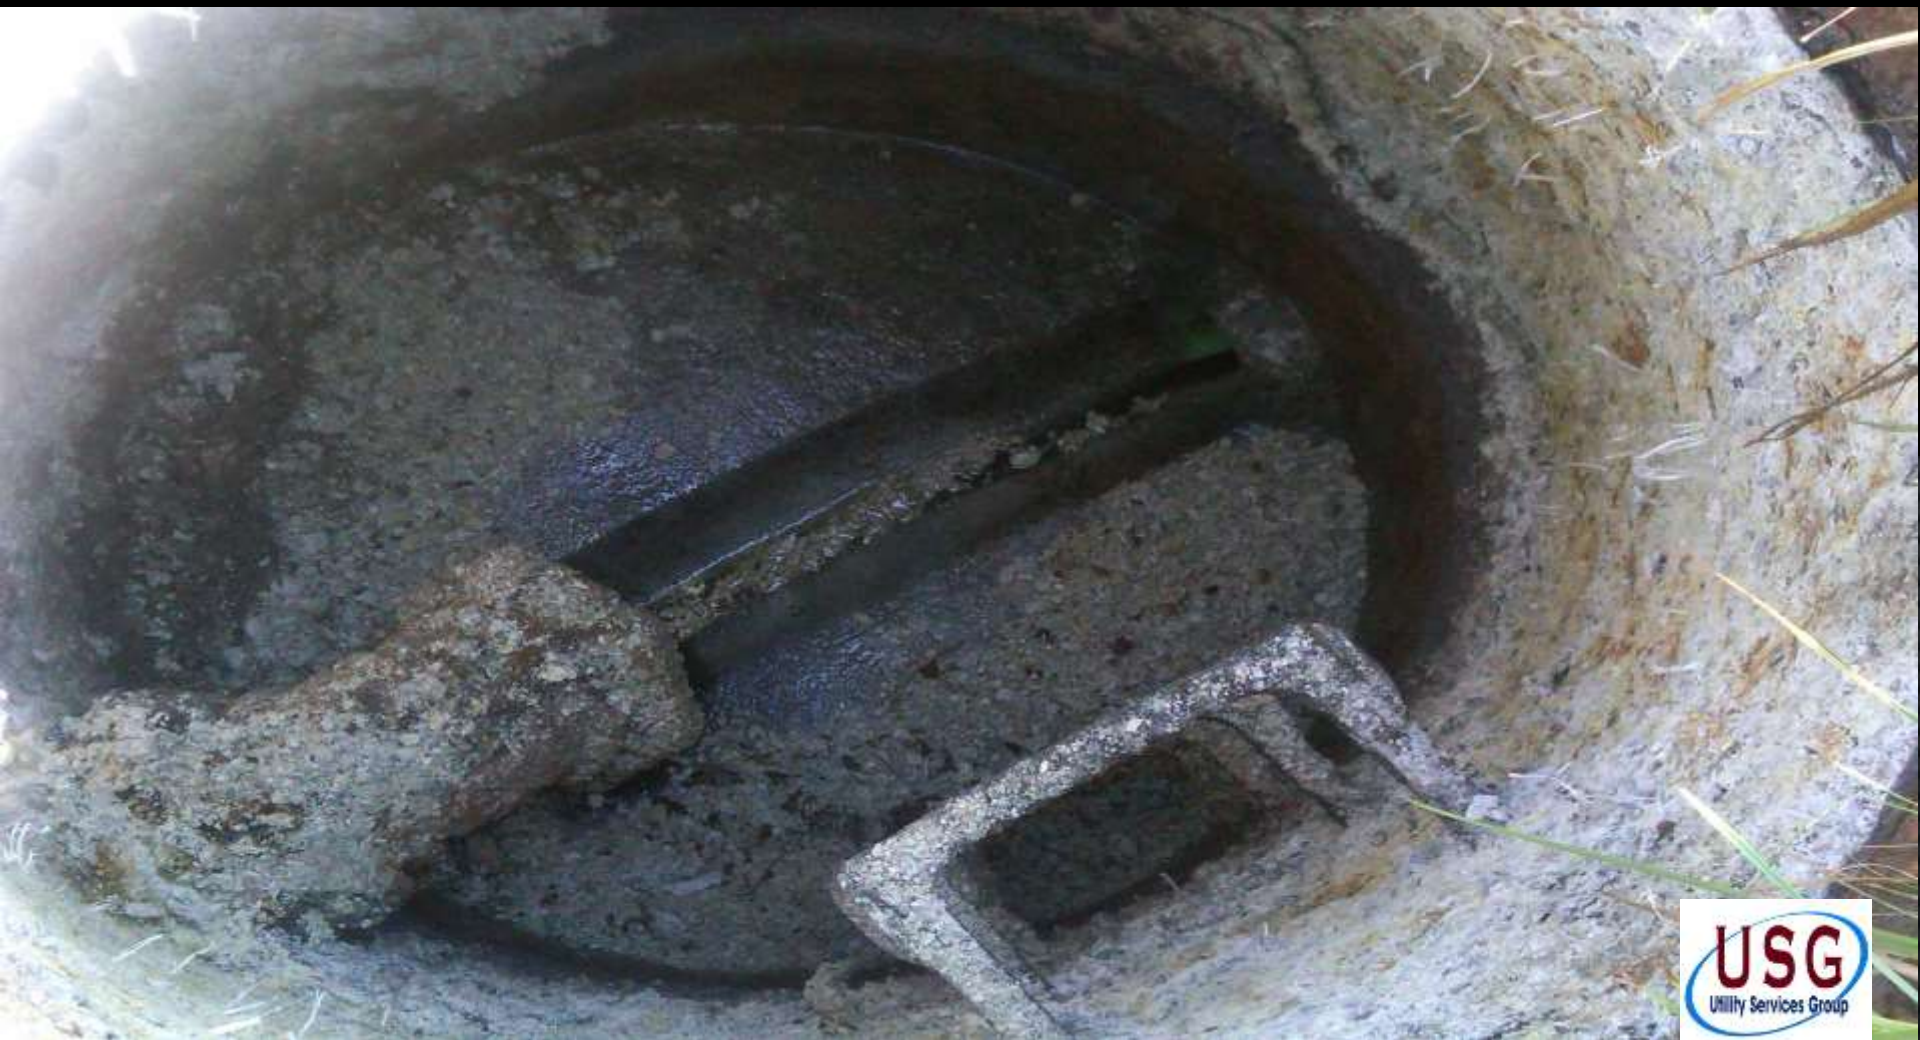
CORROSION PROBLEM

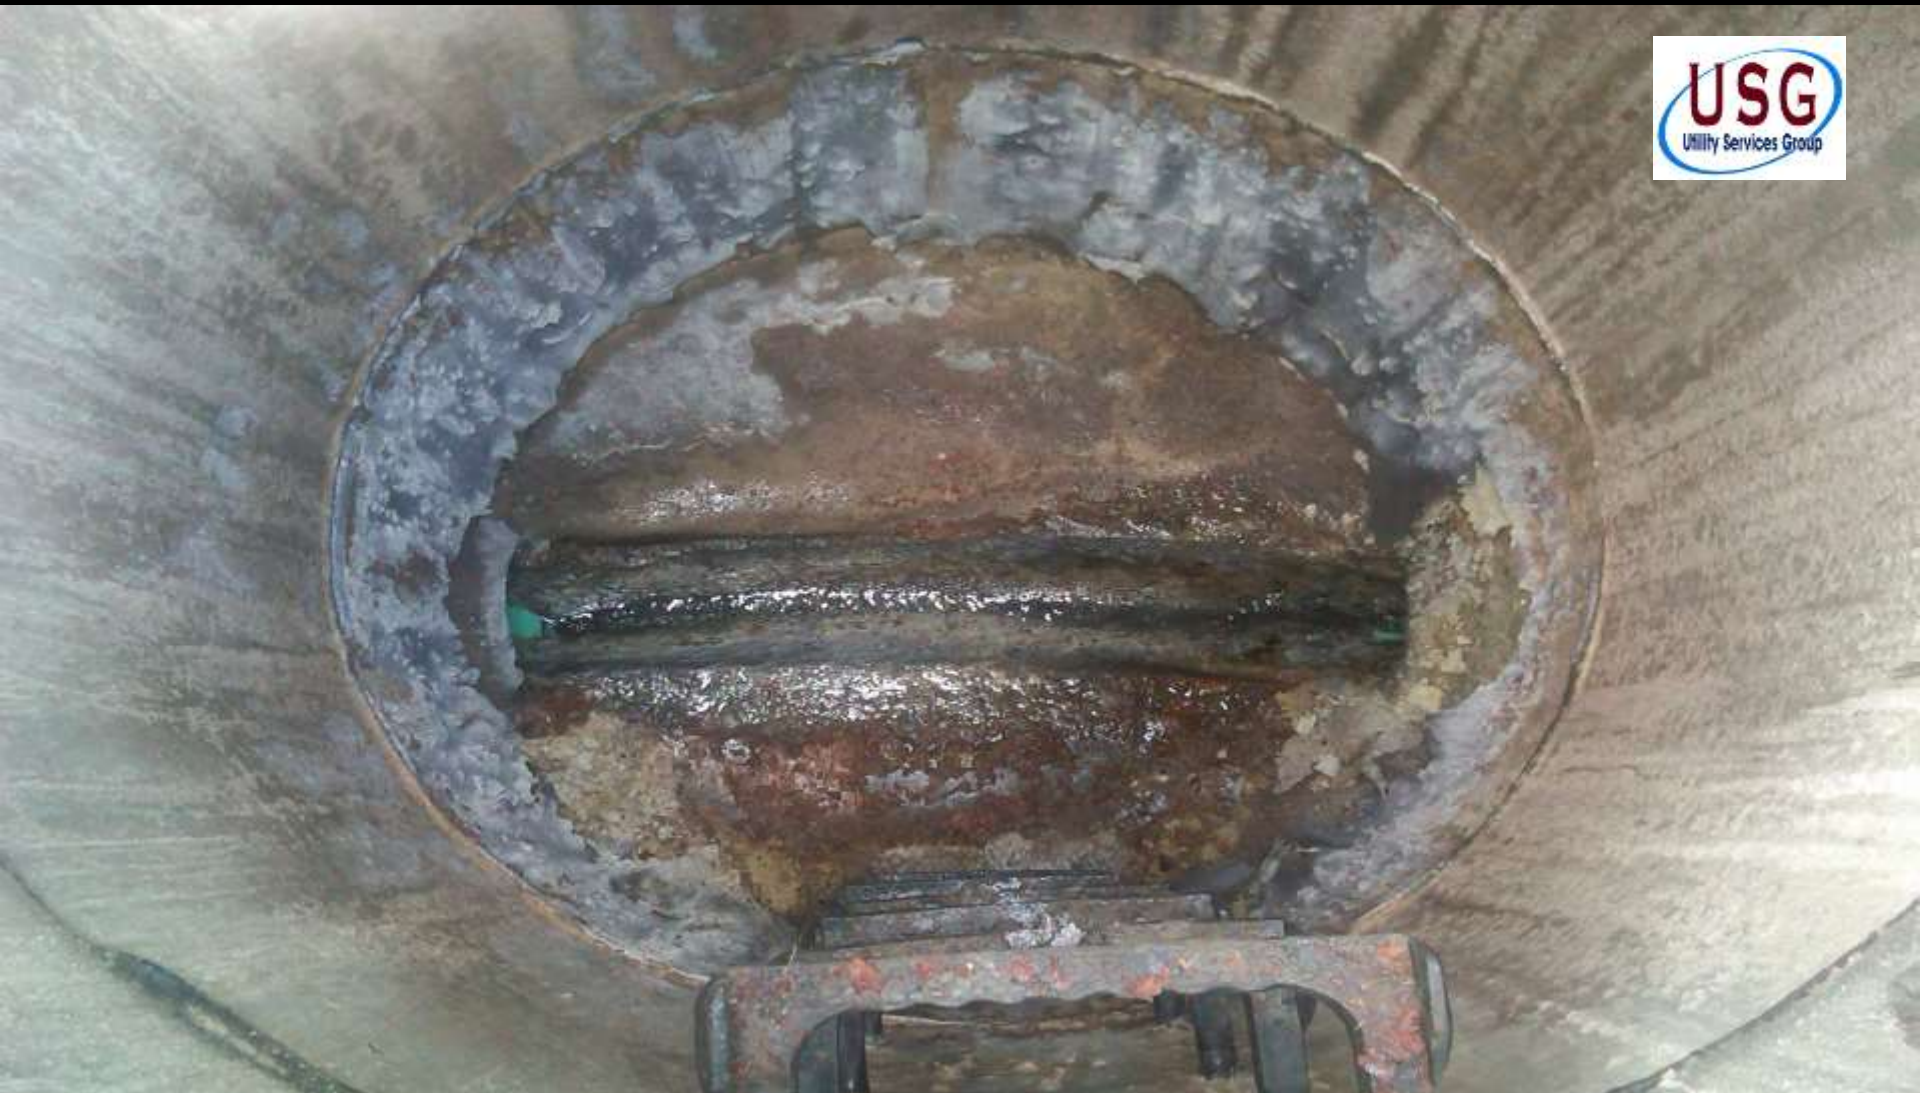
2ND MANHOLE FROM FORCEMAIN

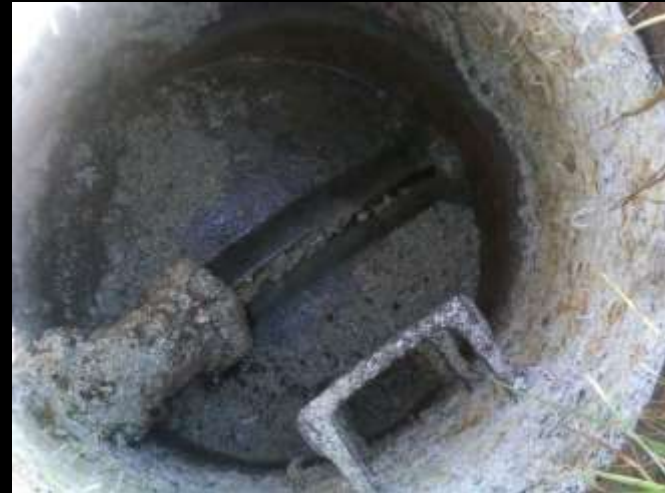
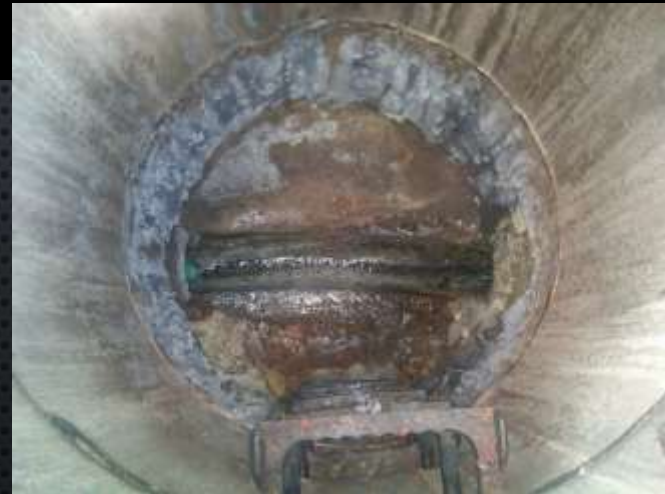
H₂S DAMAGE

- USUALLY LOCALIZED NEAR FORCE MAIN DISCHARGE POINTS
- REHABILITATION OF H₂S PRONE STRUCTURES IS EXPENSIVE

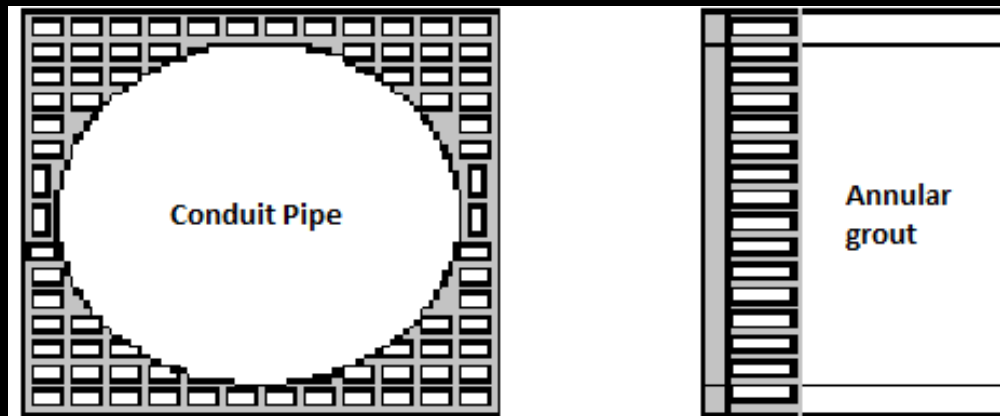
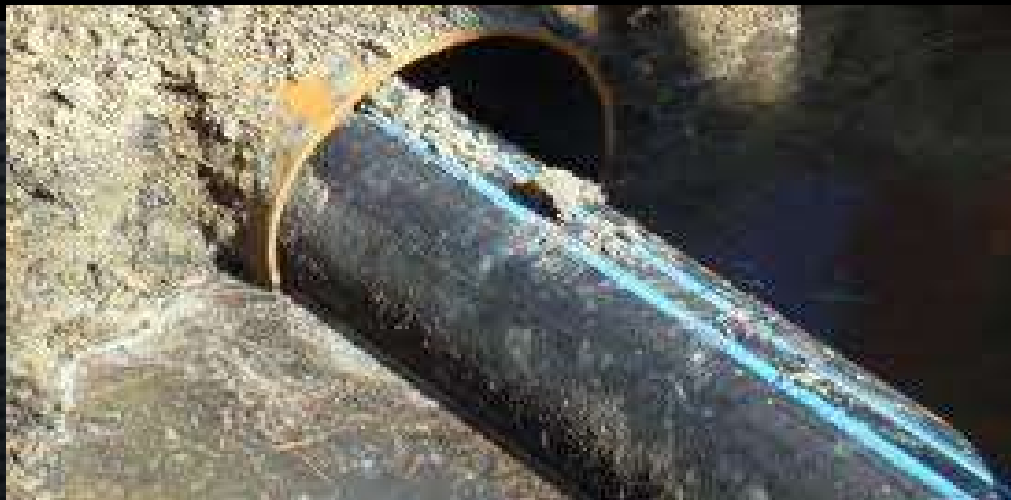
CONCEPT OF SLIP LINING

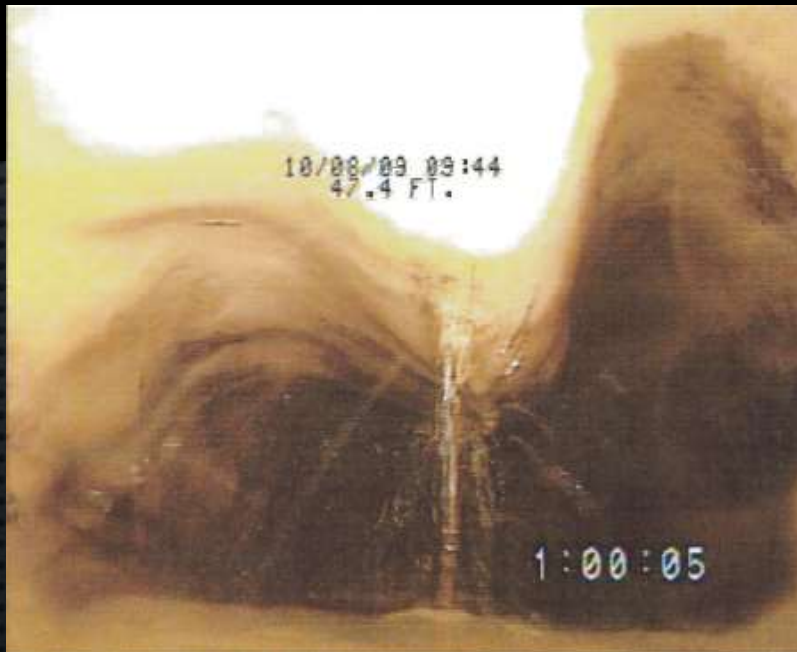
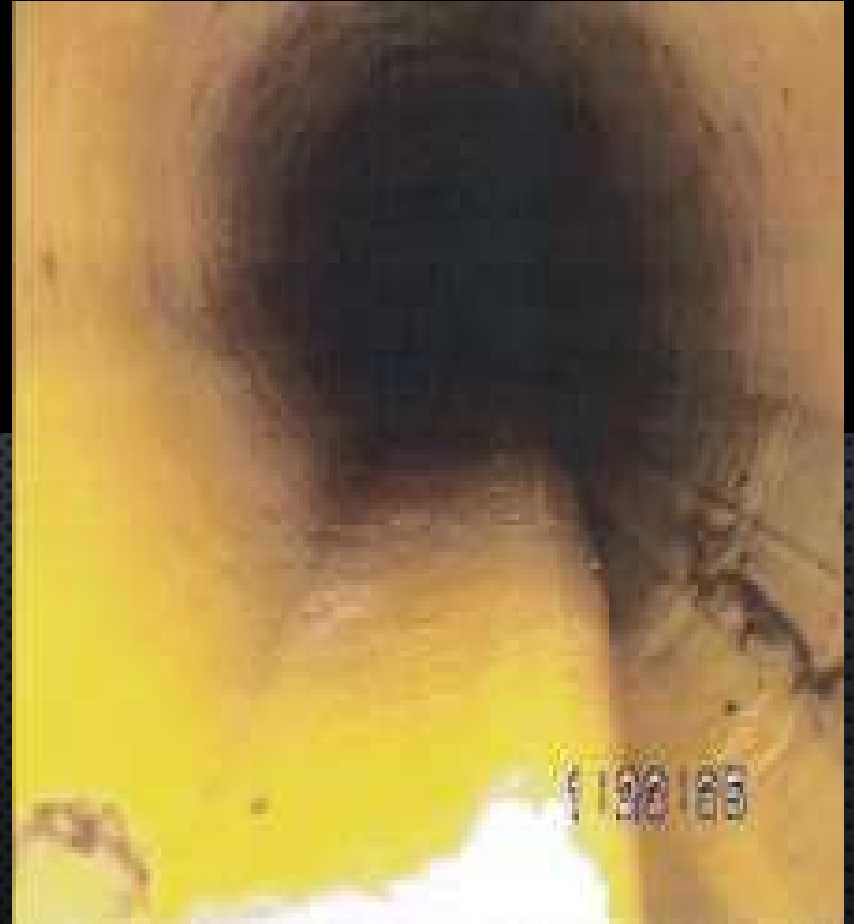
IMPORTANCE OF POST-CCTV

- INSTALLATION INSPECTION
- POST-CCTV VERIFICATION

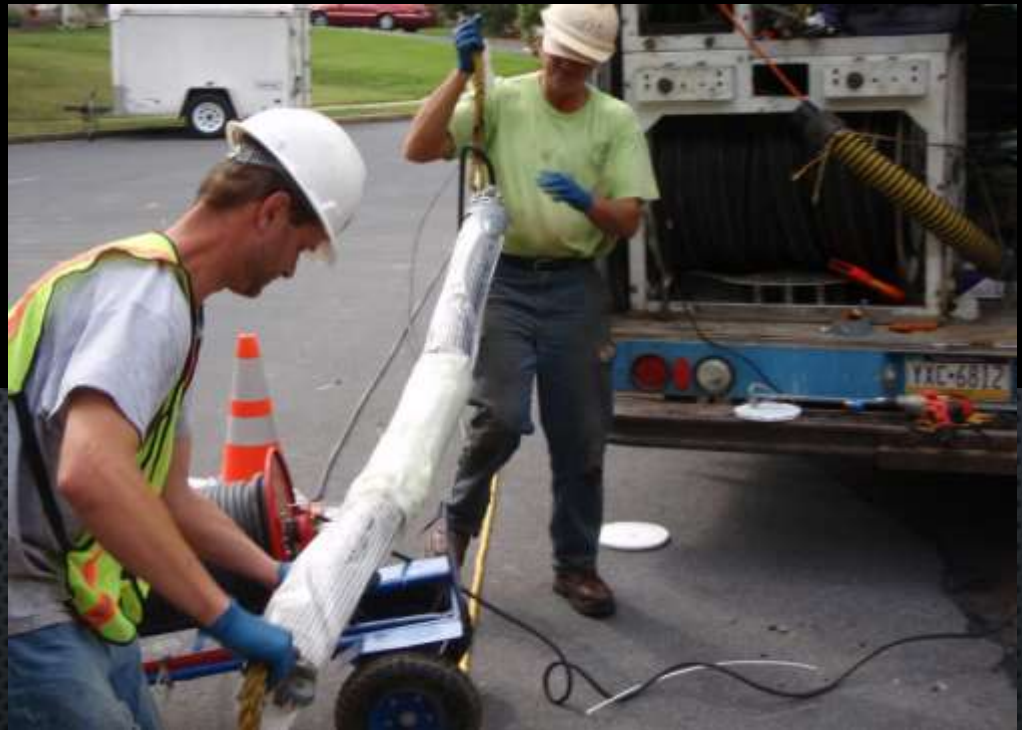
CURED-IN-PLACE SECTIONAL REPAIR

- “SURGICAL APPROACH”
- COST-EFFECTIVE
- 2'-20' REPAIRS
