2017 Annual Conference

COLLECTION REHAB
AND MAINTENANCE

COLLECTION REHAB AND MAINTENANCE

PART 1 - WASTEWATER COLLECTION SYSTEM OVERVIEW

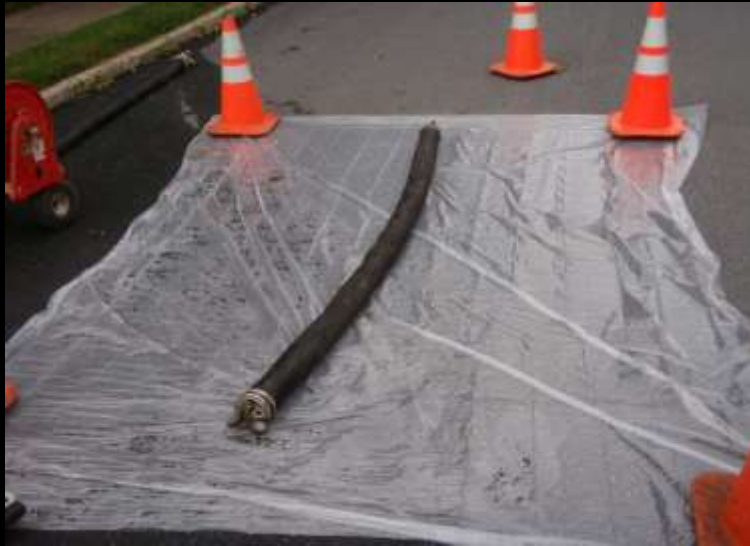
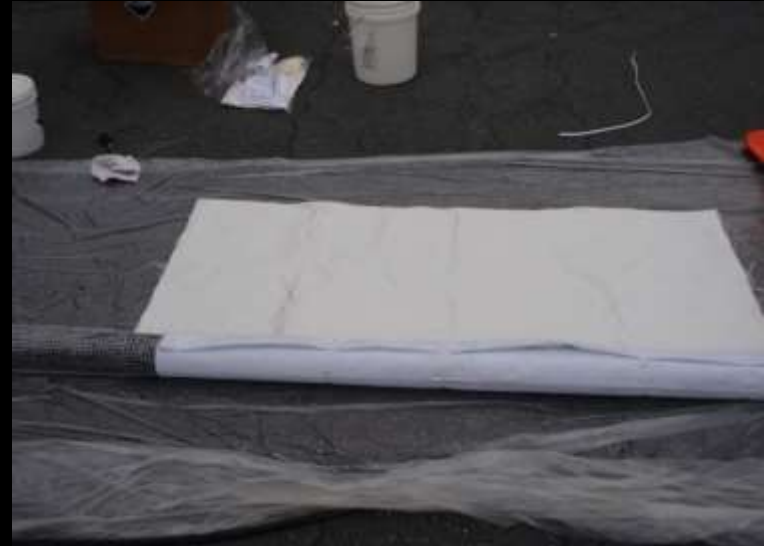
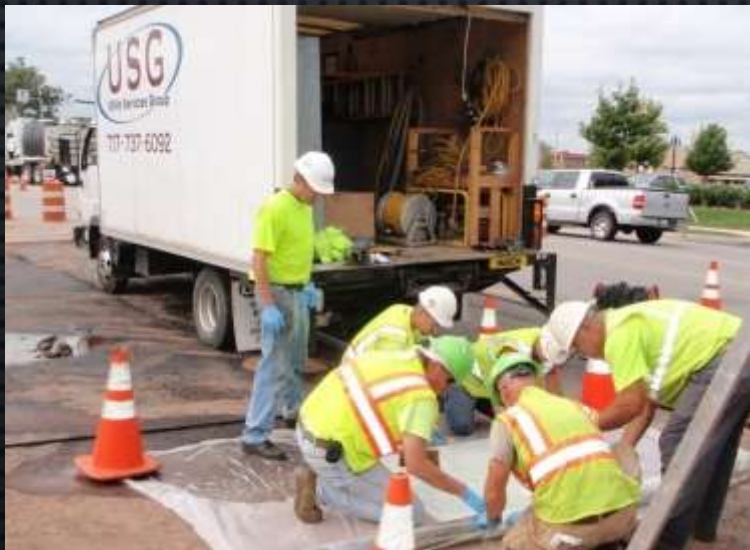
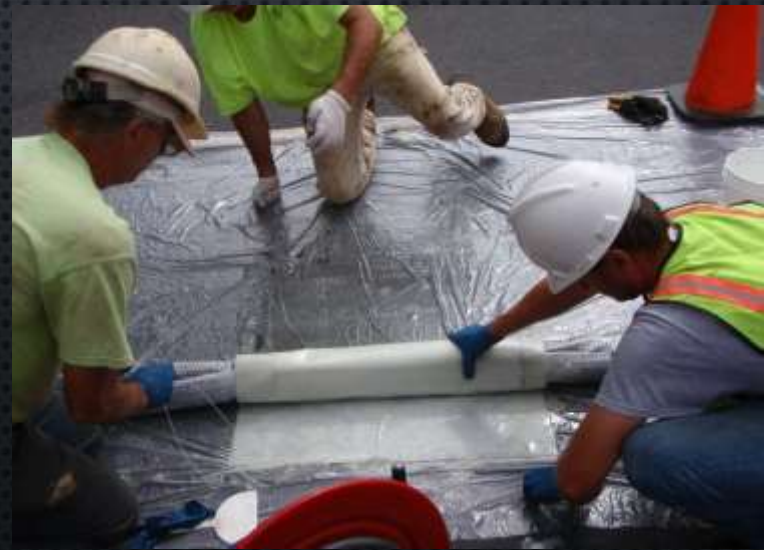
CURED-IN-PLACE SECTIONAL REPAIR

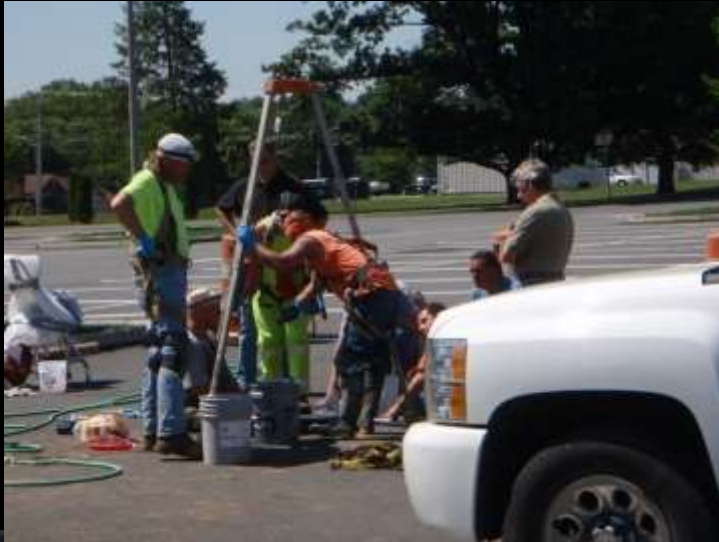
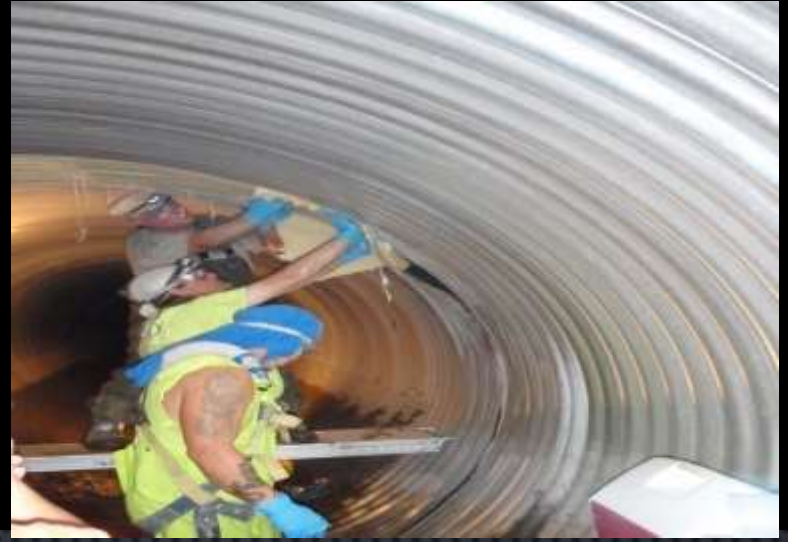
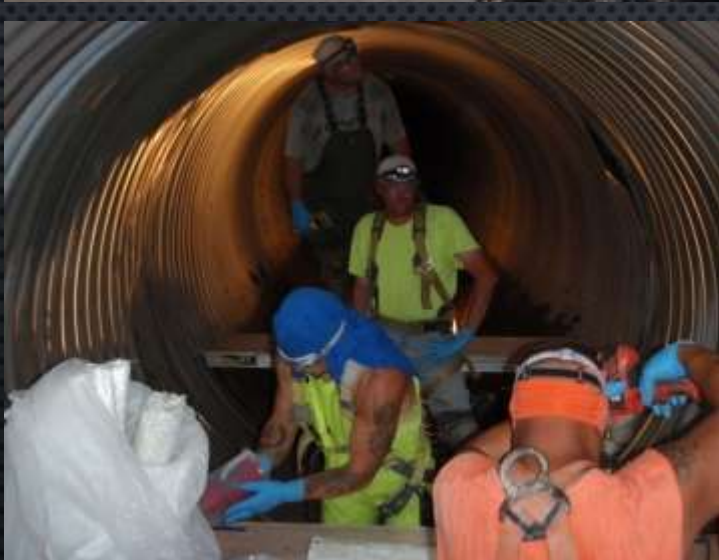
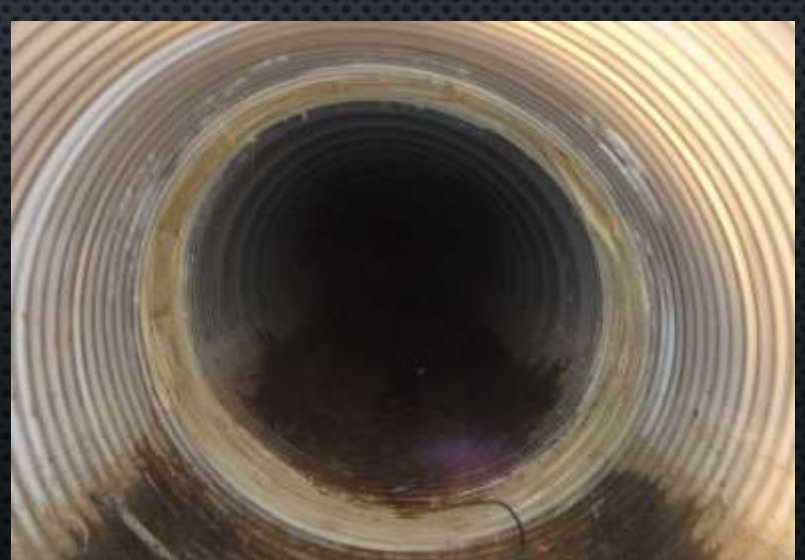
LARGE DIAMETER PIPE REPAIR

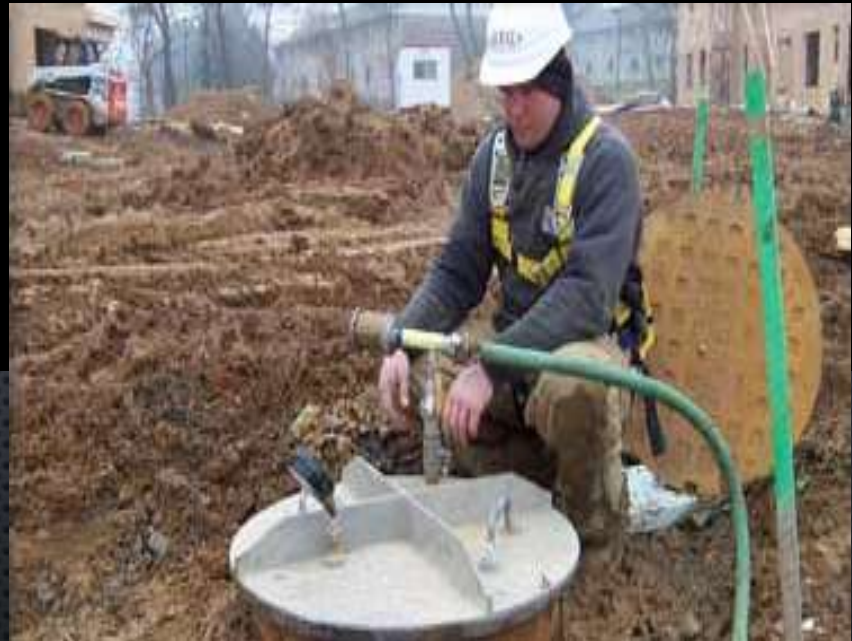
3RD PARTY NEW CONSTRUCTION TESTING

- FLUSH AND CCTV NEW PIPES
- MANDRILL / LASER PROFILE
- PRESSURE TESTING
- VACUUM TEST MANHOLES

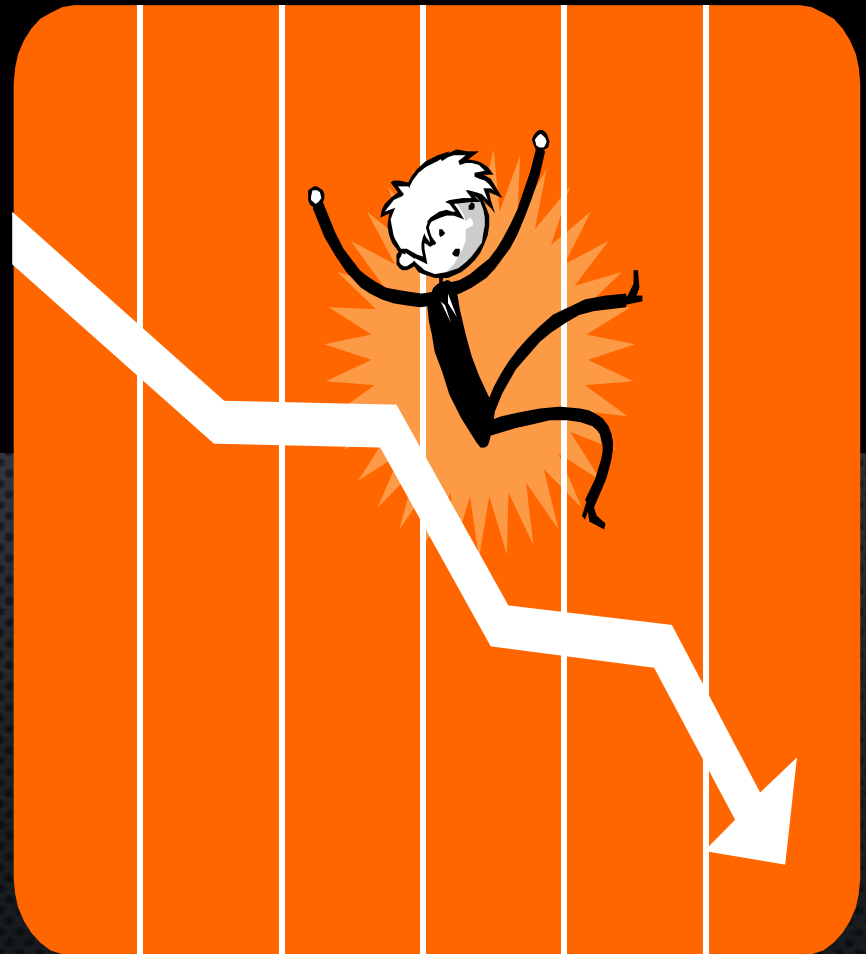
POST-REHAB FLOW DATA

- DID IT WORK?
 - PRE- AND POST REHAB EVALUATION
 - ARE THE FLOWS DOWN?
 - MONITOR PEAKS
 - MONITOR DURATION
